Radiological Case of the Month

Annie Jill Rohan, MSN, RNC, NP/NNP; Sergio U. Golombek, MD; Alan D. Rosenthal, MD; Beverly P. Wood, MD

Nasal Foreign Body Simulating Headache From Shunt Malfunction

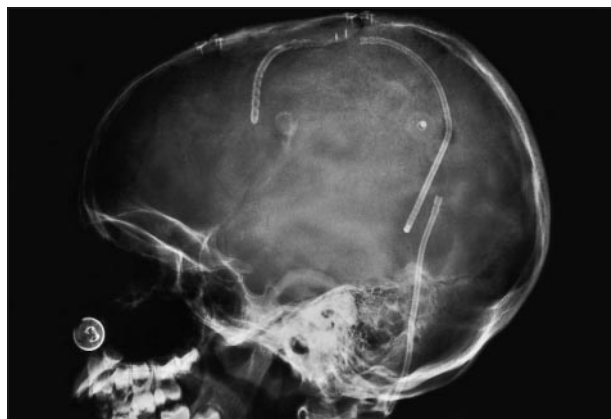
Figure 1. Lateral skull radiograph shows 2 proximal shunt tips in the region of the lateral ventricle, one placed from a frontal location, the other from a parietal location. (The proximal end of a shunt shows multiple small perforations visualized on a radiograph.) These are connected at the location where a radiolucent reservoir and valve join. This valve connects to the distal tubing at a temporal location. Craniotomy closure hardware is present at 3 superficial locations. No shunt disconnection is seen. A circular metal foreign body is noted in the region of the nose.

Radiographs of the head and neck were obtained to evaluate the shunt and better define any surgical hardware that might have affected the MRI (**Figure 1** and **Figure 2**). Radiographs were interpreted as showing discontinuity of the shunt at 2 locations. The child was referred to a neurosurgeon for evaluation of headache believed to be related to shunt disconnection or malfunction.

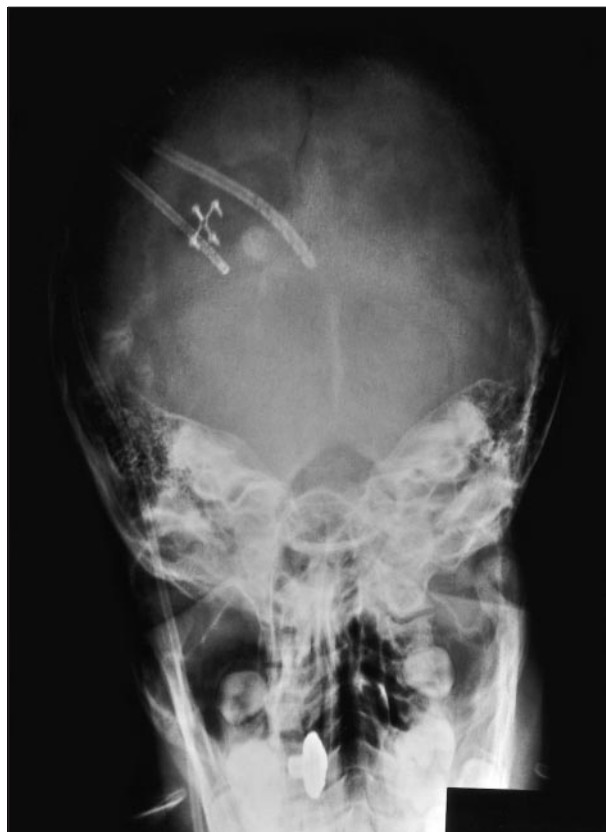
Figure 2. Anterior-posterior skull radiograph shows 2 proximal shunt tips in the region of the right lateral ventricle with tubing coursing down the right side of the skull and neck. (Note the distance between the parietal proximal shunt tip and the superficially located distal tubing, which was confused with a disconnection in Figure 1.) The craniotomy closure hardware is present. A button-shaped metallic foreign body is present overlying the face.
