## Radiological Case of the Month

## Nasal Foreign Body Simulating Headache From Shunt Malfunction

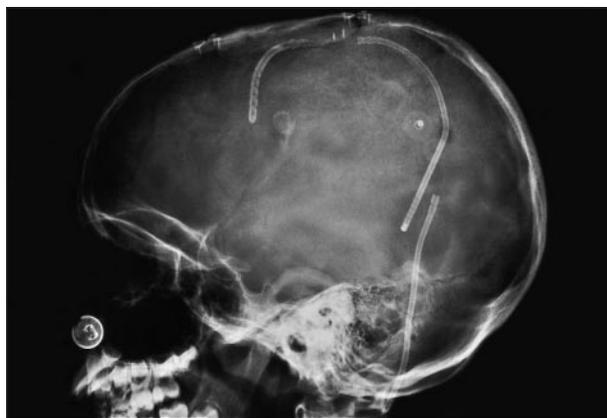
Figure 1.

**Figure 1.** Lateral skull radiograph shows 2 proximal shunt tips in the region of the lateral ventricle, one placed from a frontal location, the other from a parietal location. (The proximal end of a shunt shows multiple small perforations visualized on a radiograph.) These are connected at the location where a radiolucent reservoir and valve join. This valve connects to the distal tubing at a temporal location. Craniotomy closure hardware is present at 3 superficial locations. No shunt disconnection is seen. A circular metal foreign body is noted in the region of the nose.

Radiographs of the head and neck were obtained to evaluate the shunt and better define any surgical hardware that might have affected the MRI (**Figure 1** and **Figure 2**). Radiographs were interpreted as showing discontinuity of the shunt at 2 locations. The child was referred to a neurosurgeon for evaluation of headache believed to be related to shunt disconnection or malfunction.

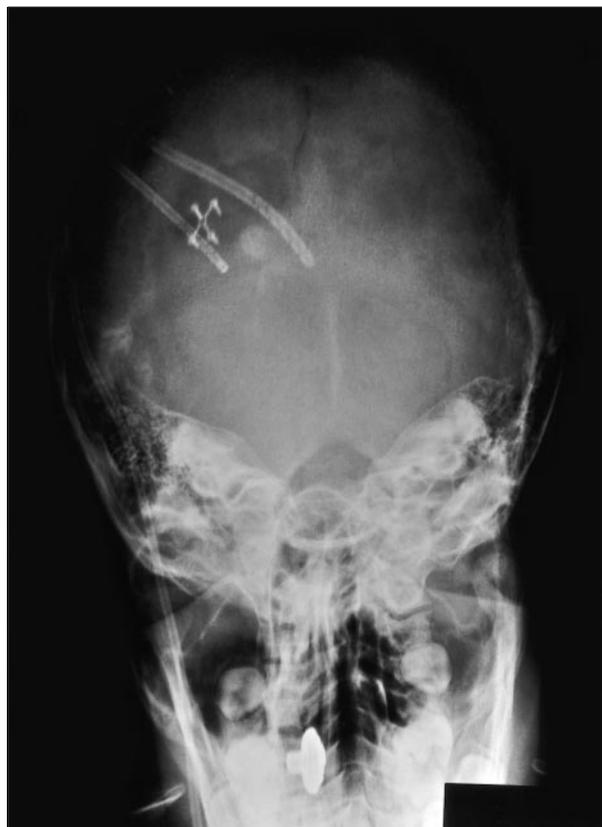
Figure 2.

**Figure 2.** Anterior-posterior skull radiograph shows 2 proximal shunt tips in the region of the right lateral ventricle with tubing coursing down the right side of the skull and neck. (Note the distance between the parietal proximal shunt tip and the superficially located distal tubing, which was confused with a disconnection in Figure 1.) The craniotomy closure hardware is present. A button-shaped metallic foreign body is present overlying the face.
